## Sites Dam Site

The Sites Dam site is in a narrow, V-shaped water gap on Stone Corral Creek about a quarter of a mile east of the town of Sites and 8 miles west of the town of Maxwell in Colusa County (Photo 2). It is in Sec. 20, R4W, T17N on the Sites 7.5-minute USGS topographic quadrangle. The proposed dam, in conjunction with the Golden Gate Dam and the Sites northern saddle dams, would impound 1.8 million acre-feet of water in Sites Reservoir. The dam would be a 277-foot high embankment structure with a 900-foot crest length at an elevation of 540 feet. No spillway is associated with Sites Dam. The only spillway is part of the Golden Gate outlet works just south of the Golden Gate Dam site.

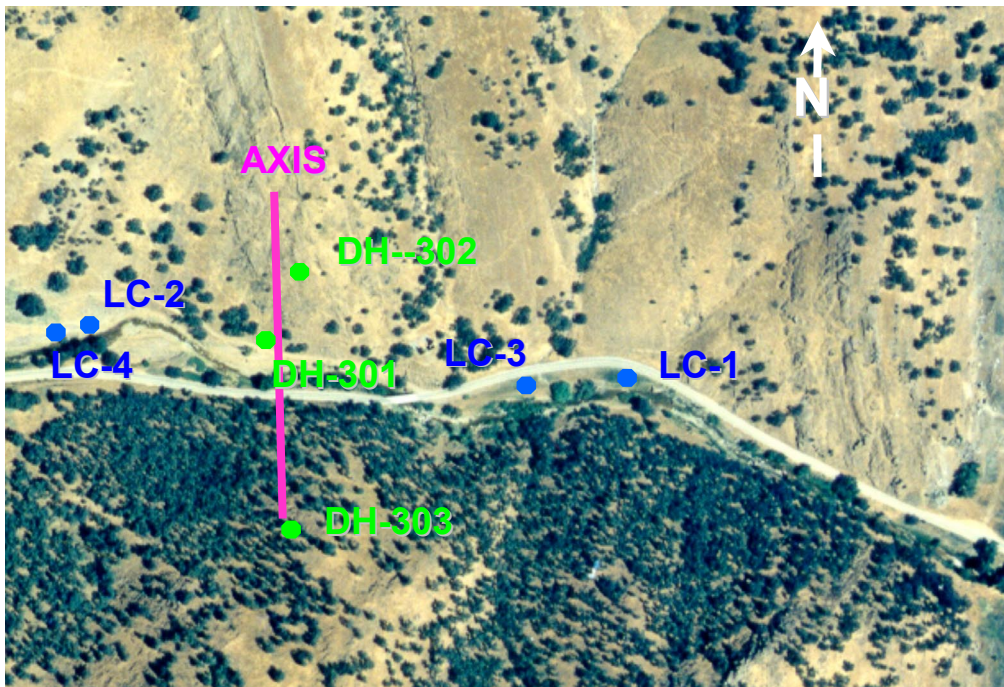
Photo 2: Aerial view of Sites Dam site on Stone Corral Creek

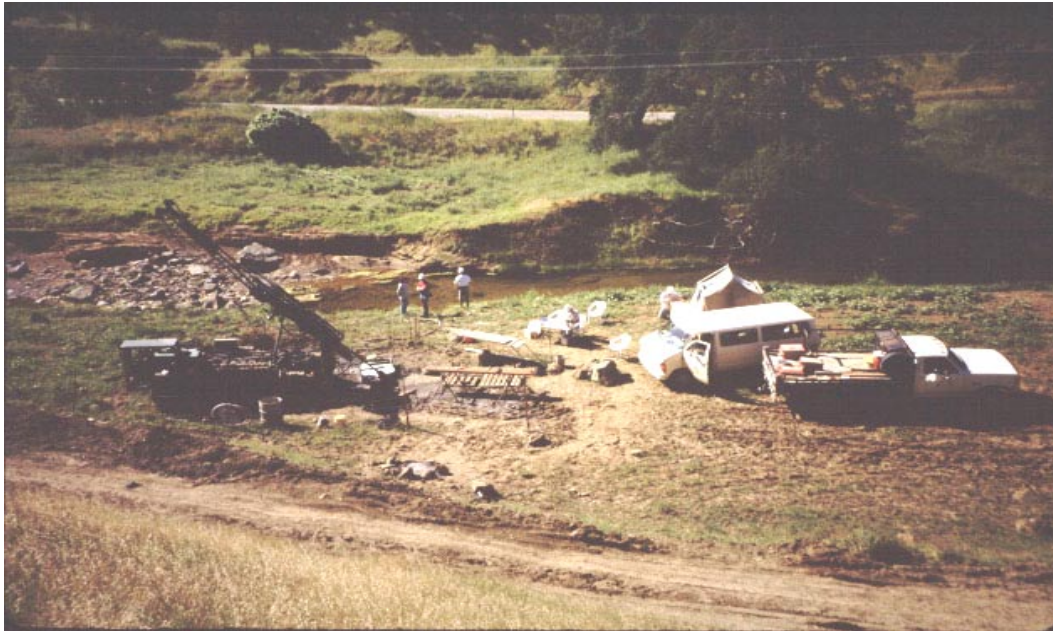
Angle drill hole LC-2 was drilled to evaluate the possible existence of the Salt Lake fault or associated deformation in the upstream footprint of the proposed dam axis (Photo 4). It was oriented cross-channel at S62°W to also explore the possibility of a "blind" or hidden fault under the alluvium that trends nearly parallel with Stone Corral Creek. It was drilled to a total depth of 202.2 feet. The upper 0.0 to 20.5 feet are composed of terrace deposits consisting of a mostly lean clay. From 20.5 to 39.0 feet, the hole drilled through 80 percent mudstone with 20 percent siltstone interbeds. From 39.0 to 50.7 feet, the hole drilled through 50 percent mudstone and 50 percent siltstone interbeds. From 50.7 to 72.0 feet, it intersected 80 percent sandstone with 20 percent mudstone interbeds. From 72.0 to 202.2 feet, the hole drilled through 80 percent mudstone with 20 percent sandy siltstone interbeds. It also intersected minor shears from 39.7 to 39.9 feet, 194.2 to 194.7 feet, and a shear zone from 111.7 to 121.0 feet. These zones contained slickensides and fracturing that may be related to the S-2 fault (Photo 5).

**Photo 4. CME - 850 drill rig at Sites Dam site drill hole LC-2**
